State of Nevada
Department of Health & Human Services
Division of Mental Health & Development Services
Desert Regional Center
Facility Condition Analysis

DESERT REGIONAL CENTER

1391 South Jones Blvd.
Las Vegas, Nevada 89146

Site Number: 9993
STATE OF NEVADA PUBLIC WORKS DIVISION
FACILITY CONDITION ANALYSIS

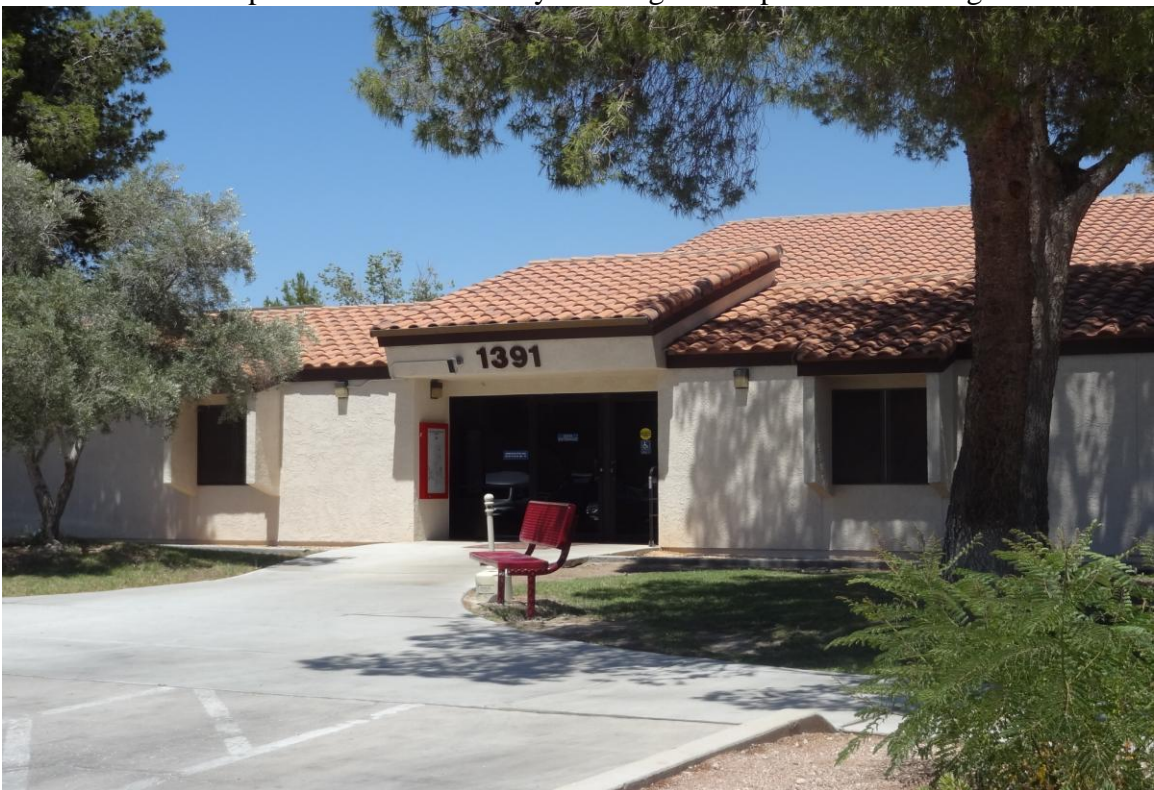
There are numerous places where drainage ponding occurs on Transverse Drive. The entire roadway should be removed and replaced, and a sidewalk with curb and gutter should be installed along the north side of Transverse Drive, after grading occurs to achieve proper drainage. This project provides for removal and replacement of the asphalt paving and concrete sidewalks. 40,000 square feet of roadway and sidewalks was used to generate the estimate.

Desert Regional Center Site – FCA Site #9993
Description: Circular drive by building #1300 prone to flooding.
